**Flood Control Project Maintenance
Levee Inspections**

Fall 2015 Levee Maintenance Deficiency Summary Report

Sacramento River Basin

Sutter Maintenance Yard East Levee Sacramento River

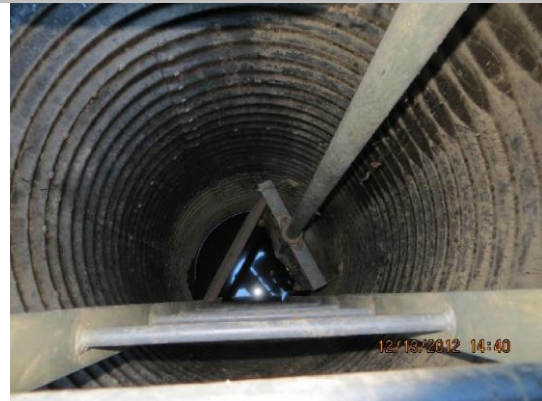
Photo 1 of 3 : UCIP_FA_2015_2824.jpg

LM Start	1.17	Rating **	U	Issue No.	137
LM End	1.17	Issue Type +	En	Location *	WS
Category	Supplemental			GPS Latitude/Longitude	
				Start	End
Item	DWR UCIP Field Study			39.194106 °	39.194106 °
				-121.953512 °	-121.953512 °
DWR ID					
Action/Comments					
Inspector Comments: FS_ID:44135					
DS_ID:17319					
EP_NO: 9527					
FS_HLM: 1.111					
Repair Type: Urgent					
Crossing Status: Found					
UCIP Comments: 4/6/2015 Pipe leaks during times of High water.					
Slope damage still present. needs a more detailed inspection to find the leak. Abandoned and plugged/capped steel pipe on WS berm. DWR leaky pipe marker on LS (12-3). Slope failure on LS. Needs capping of LS steel pipe after detailed investigation. 7/29/2013 Pipe does not appear to be abandoned. On the WS it appears that a smaller pipe was sleeved into the 18in. pipe and then the difference capped and welded. Pump was not running at time of inspection but LS ditch near outlet was wet. LS slope damage and leaky pipe marker are still present. 12/30/2013 Same as last inspection. 6/30/2014 Same as last inspection.

Waterside view: inside CMP riser

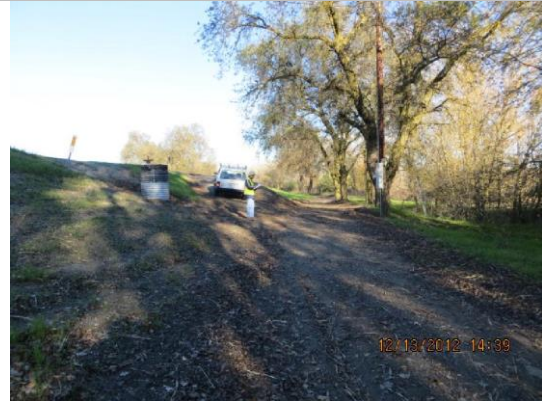
Photo 3 of 3 : UCIP_FA_2015_2826.jpg

Item	DWR UCIP Field Study			39.194106 °	39.194106 °	
				-121.953512 °	-121.953512 °	
DWR ID						
Action/Comments						
Inspector Comments: FS_ID:44135 DS_ID:17319 EP_NO: 9527 FS_HLM: 1.111 Repair Type: Urgent Crossing Status: Found UCIP Comments: 4/6/2015 Pipe leaks during times of High water. Slope damage still present. needs a more detailed inspection to find the leak. Abandoned and plugged/capped steel pipe on WS berm. DWR leaky pipe marker on LS (12-3). Slope failure on LS. Needs capping of LS steel pipe after detailed investigation. 7/29/2013 Pipe does not appear to be abandoned. On the WS it appears that a smaller pipe was sleeved into the 18in. pipe and then the difference capped and welded. Pump was not running at time of inspection but LS ditch near outlet was wet. LS slope damage and leaky pipe marker are still present. 12/30/2013 Same as last inspection. 6/30/2014 Same as last inspection. FIELD_STRUCT_DESC: 18-inch steel pipe through the levee 12.5 feet below the crown. Gate valve on the waterward side. Vertical pump on the bank. (ABO No. 9527 - Butte Creek Farms). O&M manual 136, revision May 2011 FS Date: 04/07/2015

Waterside view: overview

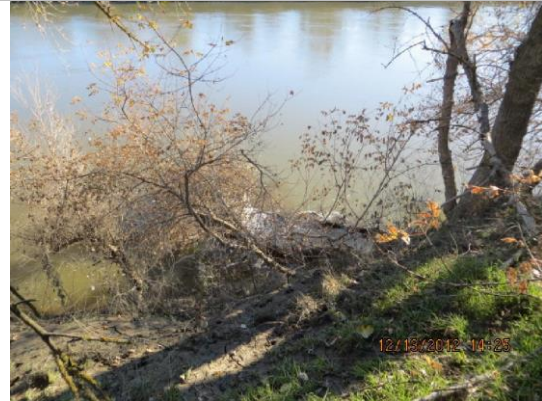
Photo 3 of 3 : UCIP_FA_2015_2829.jpg

LM Start	1.44	Rating **	U	Issue No.	138 (cont)
LM End	1.44	Issue Type +	En	Location *	LS
Category	Supplemental			GPS Latitude/Longitude	
				Start	End
Item	DWR UCIP Field Study			39.192502 °	39.192502 °
				-121.958062 °	-121.958062 °
DWR ID					
Action/Comments					
Inspector Comments: FS_ID:44136 DS_ID:17320 EP_NO: 9543 FS_HLM: 1.38 Repair Type: Urgent Crossing Status: Found

Waterside view: overview of river bank

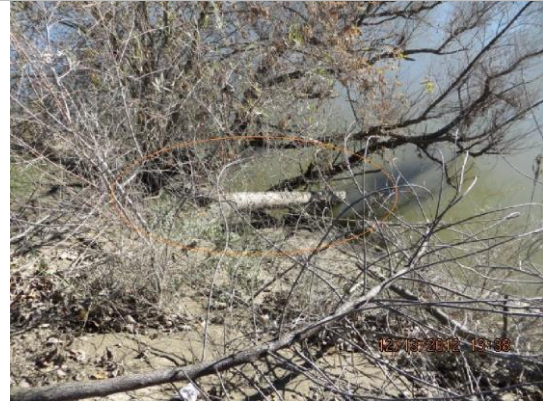
Photo 1 of 3 : UCIP_FA_2015_2833.jpg

LM Start	2.08	Rating **	M	Issue No.	140
LM End	2.08	Issue Type +	En	Location *	LS
Category	Supplemental			GPS Latitude/Longitude	
				Start	End
Item	DWR UCIP Field Study			39.187717 °	39.187717 °
				-121.967712 °	-121.967712 °
DWR ID					
Action/Comments					
Inspector Comments: FS_ID:44139					
DS_ID:17305					
EP_NO: 9541					
FS_HLM: 2.016					
Repair Type: Non-Urgent					
Crossing Status: Found

Waterside view: overview of pipe

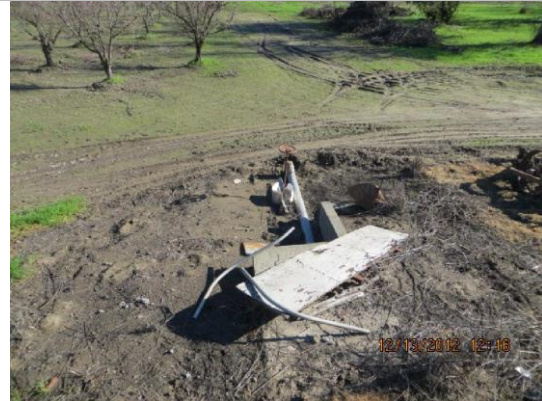
Photo 1 of 3 : UCIP_FA_2015_2861.jpg

Action/Comments					
Inspector Comments: FS_ID:44146 DS_ID:17312 EP_NO: 9539 FS_HLM: 3.35 Repair Type: Non-Urgent Crossing Status: Found UCIP Comments: 4/6/2015 6in. and 18in. pipes still present in crossing and WS end still plugged with concrete.- it seems that the system was originally designed for drainage, later converted into irrigation system. - 6-inch GI pipe and 18-inch PVC pipes inserted into culvert from LS (not plugged)- WS opening is plugged with concrete.- probably pump is located 350 ft from levee as seen from Google Earth Map.7/29/2013 Same as last inspection.12/30/2013 Same as last inspection.6/30/2014 Same as last inspection. FIELD_STRUCT_DESC: A 30-inch by 36-inch concrete culvert drain through the levee. Gates with 2-inch flashboards on the waterward end. 18-inch PVC pipe through culvert. 13.6 ft invert below crown. (ABO No. 9539 - Locvich). O&M manual 136, revision May 2011 FS Date: 04/07/2015

Landside view: overview- concrete culvert and pipes

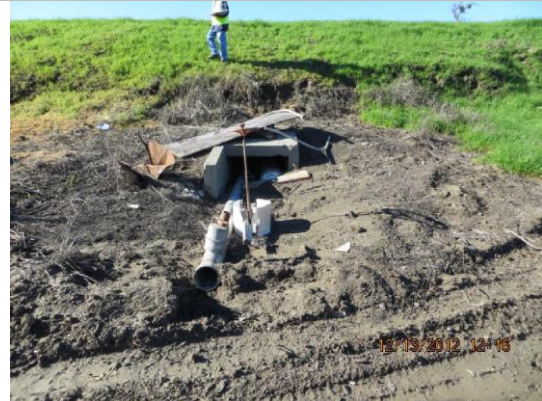
Photo 2 of 3 : UCIP_FA_2015_2862.jpg

Action/Comments					
Inspector Comments: FS_ID:44146 DS_ID:17312 EP_NO: 9539 FS_HLM: 3.35 Repair Type: Non-Urgent Crossing Status: Found UCIP Comments: 4/6/2015 6in. and 18in. pipes still present in crossing and WS end still plugged with concrete.- it seems that the system was originally designed for drainage, later converted into irrigation system. - 6-inch GI pipe and 18-inch PVC pipes inserted into culvert from LS (not plugged)- WS opening is plugged with concrete.- probably pump is located 350 ft from levee as seen from Google Earth Map.7/29/2013 Same as last inspection.12/30/2013 Same as last inspection.6/30/2014 Same as last inspection. FIELD_STRUCT_DESC: A 30-inch by 36-inch concrete culvert drain through the levee. Gates with 2-inch flashboards on the waterward end. 18-inch PVC pipe through culvert. 13.6 ft invert below crown. (ABO No. 9539 - Locvich). O&M manual 136, revision May 2011 FS Date: 04/07/2015

Landside view: overview of concrete culvert and pipes

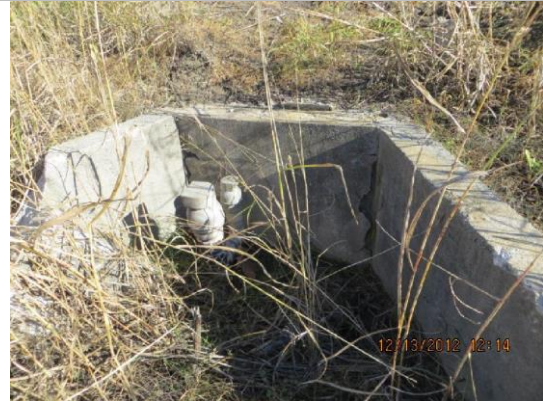
Photo 3 of 3 : UCIP_FA_2015_2863.jpg

Action/Comments					
Inspector Comments: FS_ID:44146 DS_ID:17312 EP_NO: 9539 FS_HLM: 3.35 Repair Type: Non-Urgent Crossing Status: Found UCIP Comments: 4/6/2015 6in. and 18in. pipes still present in crossing and WS end still plugged with concrete.- it seems that the system was originally designed for drainage, later converted into irrigation system. - 6-inch GI pipe and 18-inch PVC pipes inserted into culvert from LS (not plugged)- WS opening is plugged with concrete.- probably pump is located 350 ft from levee as seen from Google Earth Map.7/29/2013 Same as last inspection.12/30/2013 Same as last inspection.6/30/2014 Same as last inspection. FIELD_STRUCT_DESC: A 30-inch by 36-inch concrete culvert drain through the levee. Gates with 2-inch flashboards on the waterward end. 18-inch PVC pipe through culvert. 13.6 ft invert below crown. (ABO No. 9539 - Locvich). O&M manual 136, revision May 2011 FS Date: 04/07/2015

Waterside view: plugged concrete structure and siphon breakers

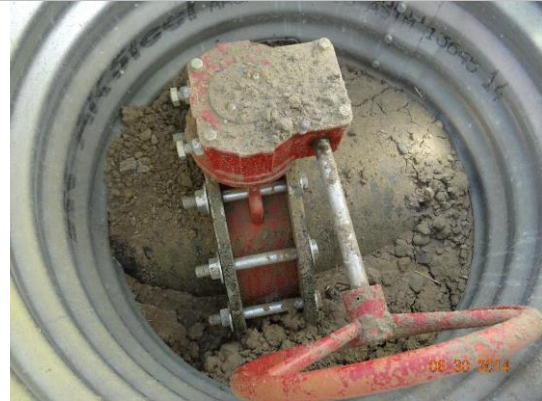
Photo 1 of 3 : UCIP_FA_2015_6633.jpg

UCIP Comments: 4/6/2015 Same as last inspection. Concrete pit on WS berm. Concrete distribution box on LS silted and erosion around the box. Slope failure/ transverse cracks on LS levee slope. Two depressions on WS berm. 7/29/2013 Repairs to LS slope and pipe are in progress. Nothing has been done yet to the WS depressions. 12/30/2013 Repairs to LS and WS slopes have been completed. Not sure if this is an active or abandoned crossing. LS distribution box is still silted in. 6/30/2014 Crossing appears to be being made active again. WS bank has been cleared of all vegetation and debris to allow pump to slide down to water level. New shutoff valve installed on WS shoulder inside of cmp stand pipe. New air-vac installed inside cmp standpipe on LS shoulder and air vent installed on LS toe. Could not Locate pipe end on LS. Need to check for permit number for work done.

WS shut off valve

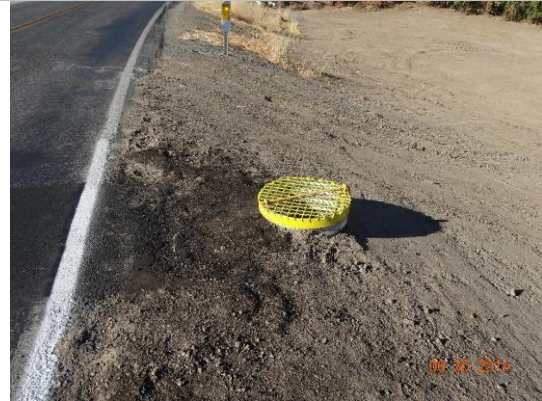
Photo 2 of 3 : UCIP_FA_2015_6634.jpg

Action/Comments					
Inspector Comments: FS_ID:44167 DS_ID:17314 EP_NO: 9501 FS_HLM: 3.794 Repair Type: Non-Urgent Crossing Status: Found UCIP Comments: 4/6/2015 Same as last inspection. Concrete pit on WS berm. Concrete distribution box on LS silted and erosion around the box. Slope failure/ transverse cracks on LS levee slope. Two depressions on WS berm. 7/29/2013 Repairs to LS slope and pipe are in progress. Nothing has been done yet to the WS depressions. 12/30/2013 Repairs to LS and WS slopes have been completed. Not sure if this is an active or abandoned crossing. LS distribution box is still silted in. 6/30/2014 Crossing appears to be being made active again. WS bank has been cleared of all vegetation and debris to allow pump to slide down to water level. New shutoff valve installed on WS shoulder inside of cmp stand pipe. New air-vac installed inside cmp standpipe on LS shoulder and air vent installed on LS toe. Could not Locate pipe end on LS. Need to check for permit number for work done. FIELD_STRUCT_DESC: 16-inch steel pipe through the levee with pump house over concrete pit on berm. No control valves visible. Discharges into concrete box at the landward toe. (ABO No. 9501 - Mayfair Farms). According to Permit 9501A, it is an existing abandoned pipe located at HLM 4.37. O&M manual 136, revision May 2011. FS Date: 04/07/2015

WS standpipe with shut off valve inside

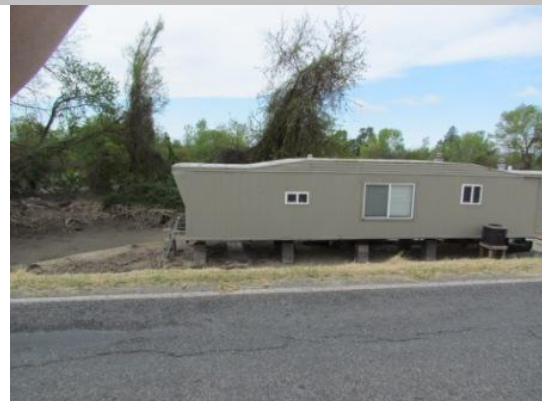
Photo 1 of 1 : FA_2015_ST0003_264_11_20150910_00003.jpg

View of the trailer next to the W/S toe.

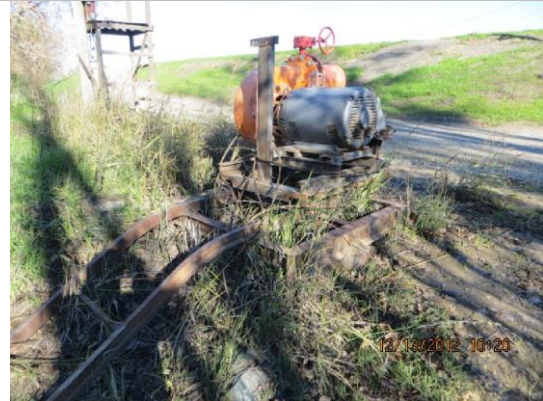
Photo 1 of 3 : UCIP_FA_2015_2888.jpg

UCIP Comments: 4/6/2015 Pump disconnected and pulled up to WS toe. Not Sure if leaky valve has ever been fixed. Motor and pump on berm. Appears an abandoned crossing. Leaky valve on LS slope. Pipe removed and laying on berm. No electric connection to the pump. 7/29/2013 Not an abandoned crossing. Pump is connected to WS pipe end at water level and is pumping water to LS and then goes underground to an irrigation ditch about 100yds. upstream. Pump and pipes are disconnected and pulled up to WS toe for high water season. Leaky valve on LS shoulder does not appear to have been fixed. 12/30/2013 Same as last inspection. 6/30/2014 Same as last inspection.

side view: pump motor on the berm

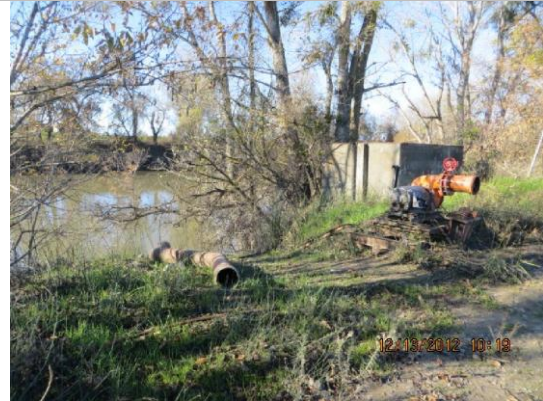
Photo 2 of 3 : UCIP_FA_2015_2889.jpg

UCIP Comments: 4/6/2015 Pump disconnected and pulled up to WS toe. Not Sure if leaky valve has ever been fixed. Motor and pump on berm. Appears an abandoned crossing. Leaky valve on LS slope. Pipe removed and laying on berm. No electric connection to the pump. 7/29/2013 Not an abandoned crossing. Pump is connected to WS pipe end at water level and is pumping water to LS and then goes underground to an irrigation ditch about 100yds. upstream. Pump and pipes are disconnected and pulled up to WS toe for high water season. Leaky valve on LS shoulder does not appear to have been fixed. 12/30/2013 Same as last inspection. 6/30/2014 Same as last inspection.

Waterside view: overview of pump and abandoned pipe

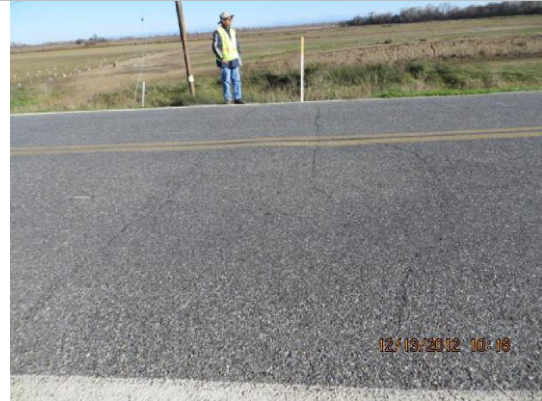
Photo 3 of 3 : UCIP_FA_2015_2890.jpg

Crown view: transverse cracks on levee road.

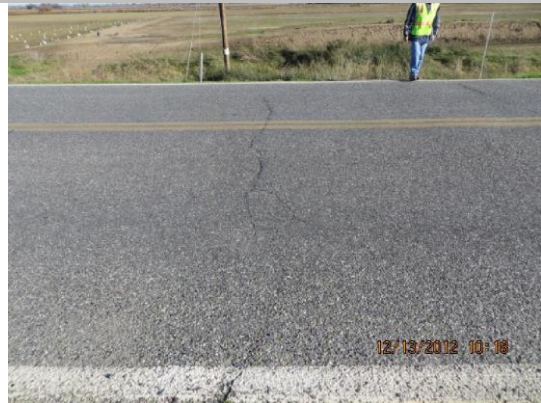
Photo 3 of 3 : UCIP_FA_2015_2679.jpg

Crown view: transverse crack on levee road

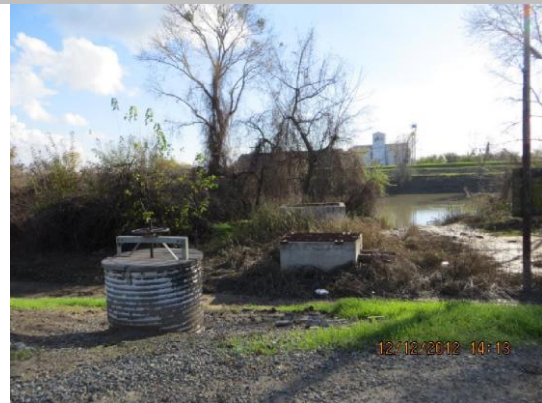
Photo 1 of 3 : UCIP_FA_2015_2842.jpg

LM Start	5.04	Rating **	U	Issue No.	148
LM End	5.04	Issue Type +	En	Location *	WS
Category	Supplemental			GPS Latitude/Longitude	
				Start	End
Item	DWR UCIP Field Study			39.214970 °	39.214970 °
				-121.997177 °	-121.997177 °
DWR ID					
Action/Comments					
Inspector Comments: FS_ID:44182 DS_ID:17289 EP_NO: 2904 FS_HLM: 4.989 Repair Type: Urgent Crossing Status: Found UCIP Comments: 4/6/2015 Reapairs are in progress to this crossing. Surge box on WS and distribution box across the county road on LS. Abandoned pump station and electrical panel on WS. A concrete pump pit on WS. 7/29/2013 Portable tow-pump lowered down WS berm to water level and is pupming water into concrete surge box on WS and the filling the irrigation ditch on LS. Sink hole with standing water that is present above the outlet pipe for the WS surge box. This may indicate a leaking pipe or cracked concrete. 12/30/2013 Sink Hole above pipe on WS still present. Pipe end inside of WS surge box shows heavy signs of rust and corrosion. Recommend having an internal camera inspection completed on pipe. 6/30/2014 Sink hole near WS surge box is still present. Portable pumps were lowered down the WS bank and were pumping water directly into WS standpipe on to by pass the surge box. FIELD_STRUCT_DESC: 36-inch corrugated metal pipe through the levee 18.4 feet below the crown. Slide gate in corrugate metal pipe riser on waterward shoulder, pump and concrete pump pit on the waterward bank. Concrete surge box on the waterward berm. Discharges into irrigation ditch on the opposite side of the county road. (App. No. 2904 - Arnold). Application was for an existing pumping system. O&M manual 136, revision May 2011. FS Date: 04/07/2015

Waterside view: CMP riser and surge box

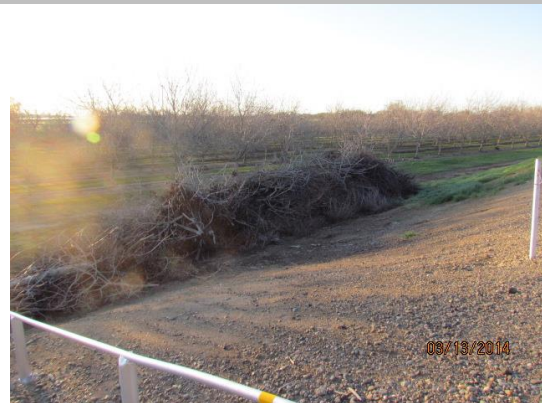
Photo 1 of 2 : FA_2015_ST0003_264_53_20150910_00016.jpg

View of the prunings along the landside toe.

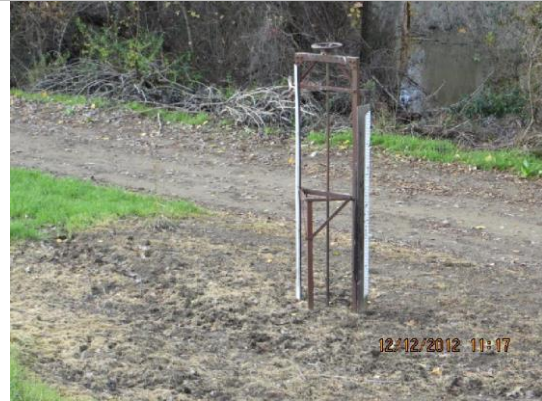
Photo 1 of 3 : UCIP_FA_2015_2689.jpg

Waterside view: buried slide gate

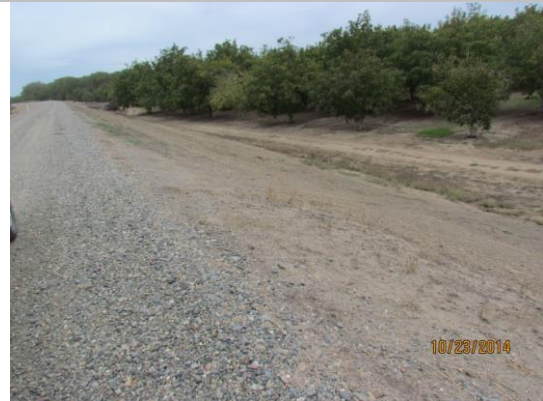
Photo 1 of 1 : FA_2015_ST0003_264_57_20150910_00019.jpg

View of the rodent holes on the landside slope.

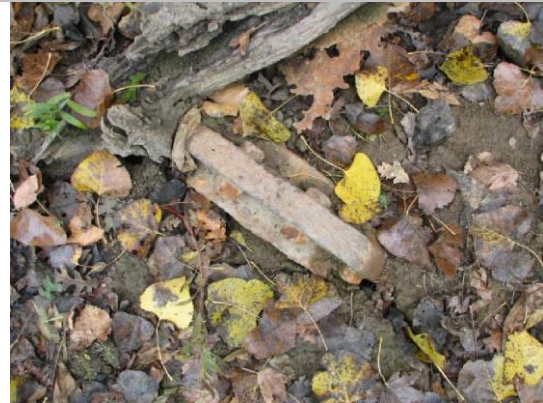
Photo 1 of 2 : UCIP_FA_2015_2650.jpg

Waterside view: abandoned and ruined pipe

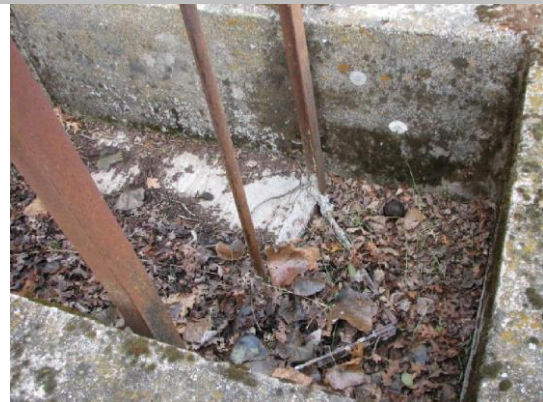
Photo 1 of 3 : UCIP_FA_2015_2652.jpg

Waterside view: abandoned pipe with cement grouting
